# LOT 5 FOX-MILLER PROPERTY

## 2009 ANNUAL REPORT

December 17, 2009

**HELIX ENVIRONMENTAL PLANNING, INC.**  
7578 El Cajon Boulevard, Suite 200  
La Mesa, California 91942

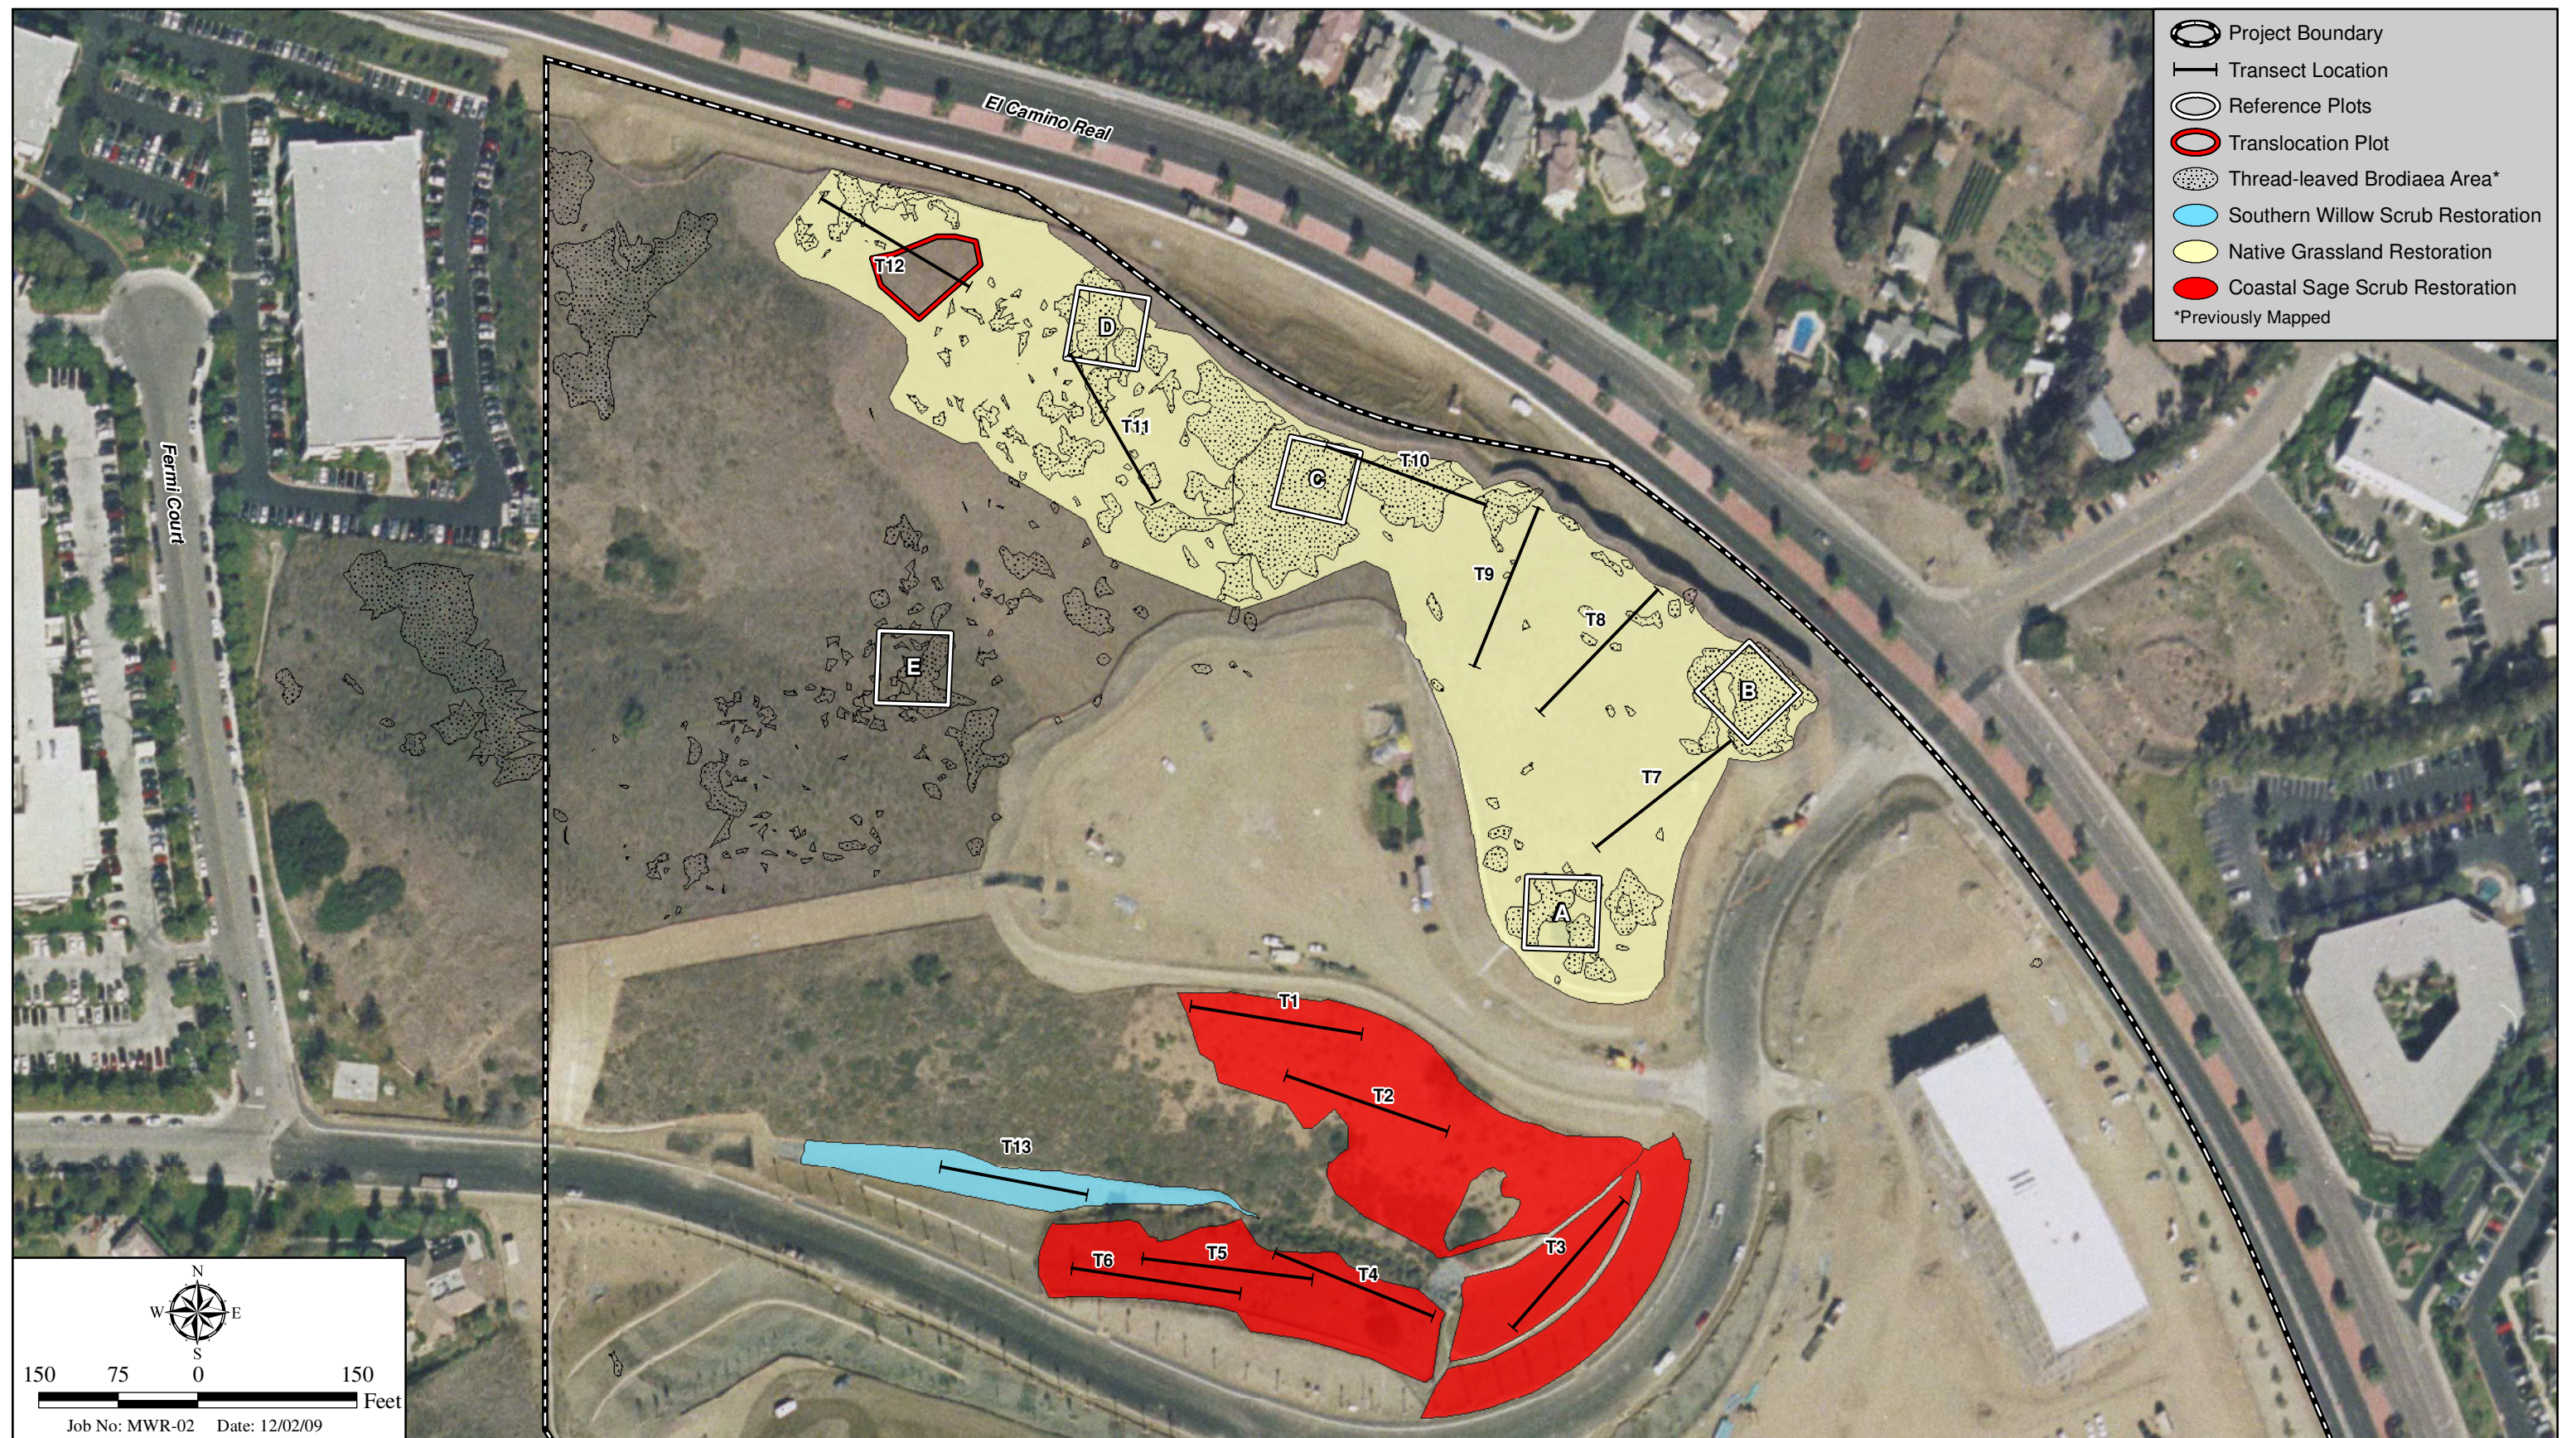
Figure 4

## Transect and Plot Locations

Thirteen (13) permanent transects were established during the Year 3 technical monitoring. Vegetation data were collected from 13 line transects: Transects 1 to 6 are located in the DCSS restoration area, Transects 7 to 12 are located in the NG restoration area, and Transect 13 is located in the SWS restoration area (Figure 4). The 2 ends of each line transect were permanently marked with a rebar stake covered with white PVC pipe. Transect lengths are

50 meters (m) and centered on a 50 m by 5 m plot (250 m<sup>2</sup>), as specified by the California Native Plant Society (1996). Monitoring consisted of point intercept (line transect) sampling methods. At every 50 centimeters (cm) along each transect (beginning at the 50-cm mark and ending at 50 m), a point was projected into the vegetation, and species intercepted by the point were recorded. Vegetation intercepts were categorized into herb (less than 60 cm), shrub (60 to 200 cm), and tree (greater than 200 cm) layers. Total cover is the percentage of points along the transect that are intercepted by vegetation. A single point may be intercepted by plants in multiple layers but would be counted only as a single point for total cover. Percent cover for herb, shrub, and tree categories were calculated for both native and non-native species.

Counts of the number of flowering thread-leaved brodiaea within the translocation plot and the 5 reference plots (Figure 4) were conducted by Mr. Kurnow on May 5, 11, and 19, 2009, and June 1, 2009. Mr. Ritenour assisted Mr. Kurnow with the plot counts on May 5, 2009. Reference plots are the same size as the translocation plot. Data was collected on 4 separate occasions within the blooming period, and data collection occurred the same day for each plot. A GPS unit with sub-meter accuracy was used to record the number of flowering individuals per plot. Data within each plot was overlaid and individuals that were recorded multiple times were not double counted in the analysis below.

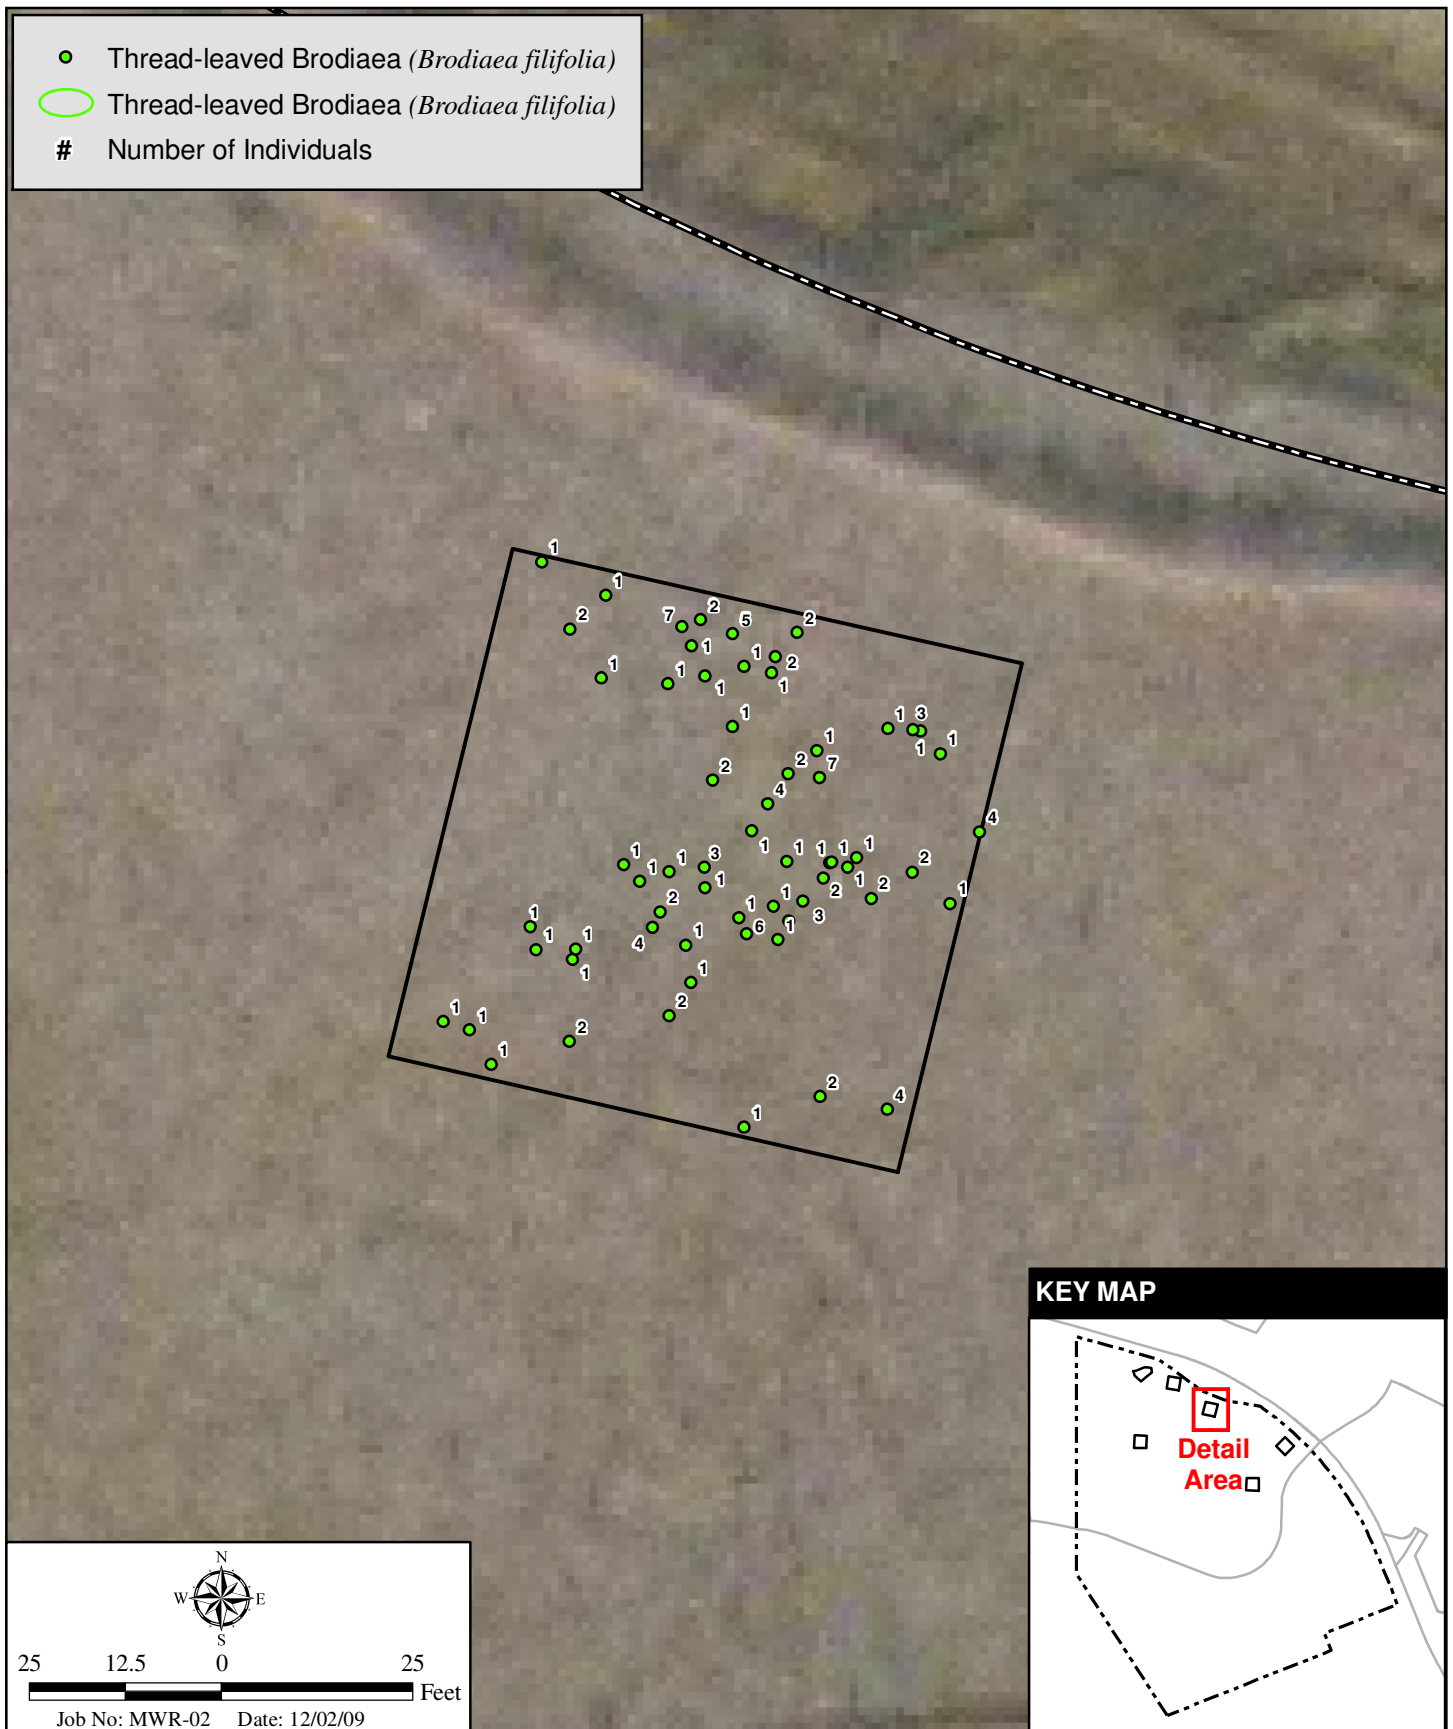
Figure 5d

# **Quantity and Distribution of Flowering Thread-leaved Brodiaea (*Brodiaea filifolia*) Individuals - Reference Plot C**

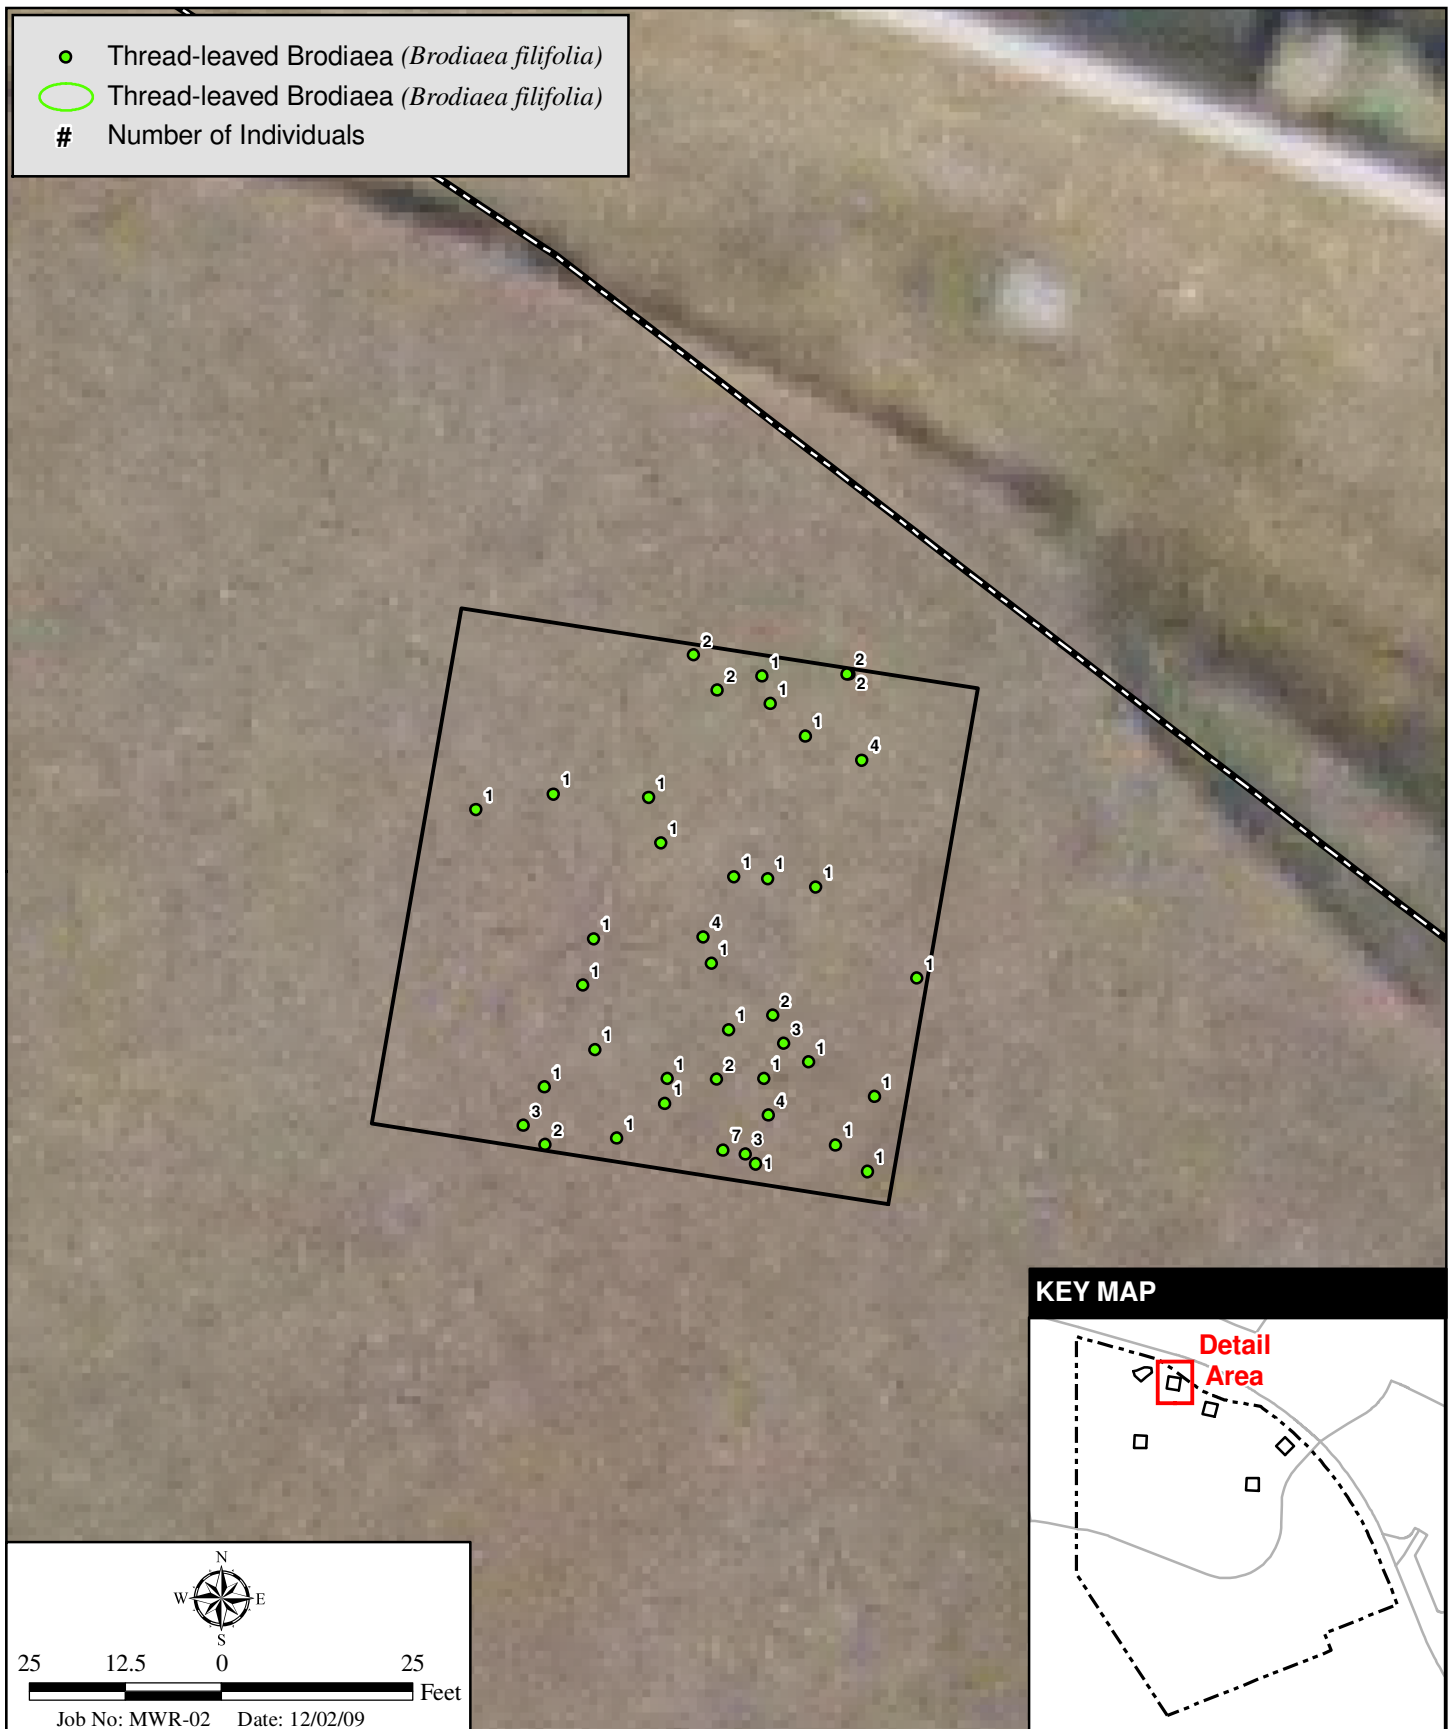
Figure 5e

# Quantity and Distribution of Flowering Thread-leaved *Brodiaea (Brodiaea filifolia)* Individuals - Reference Plot D

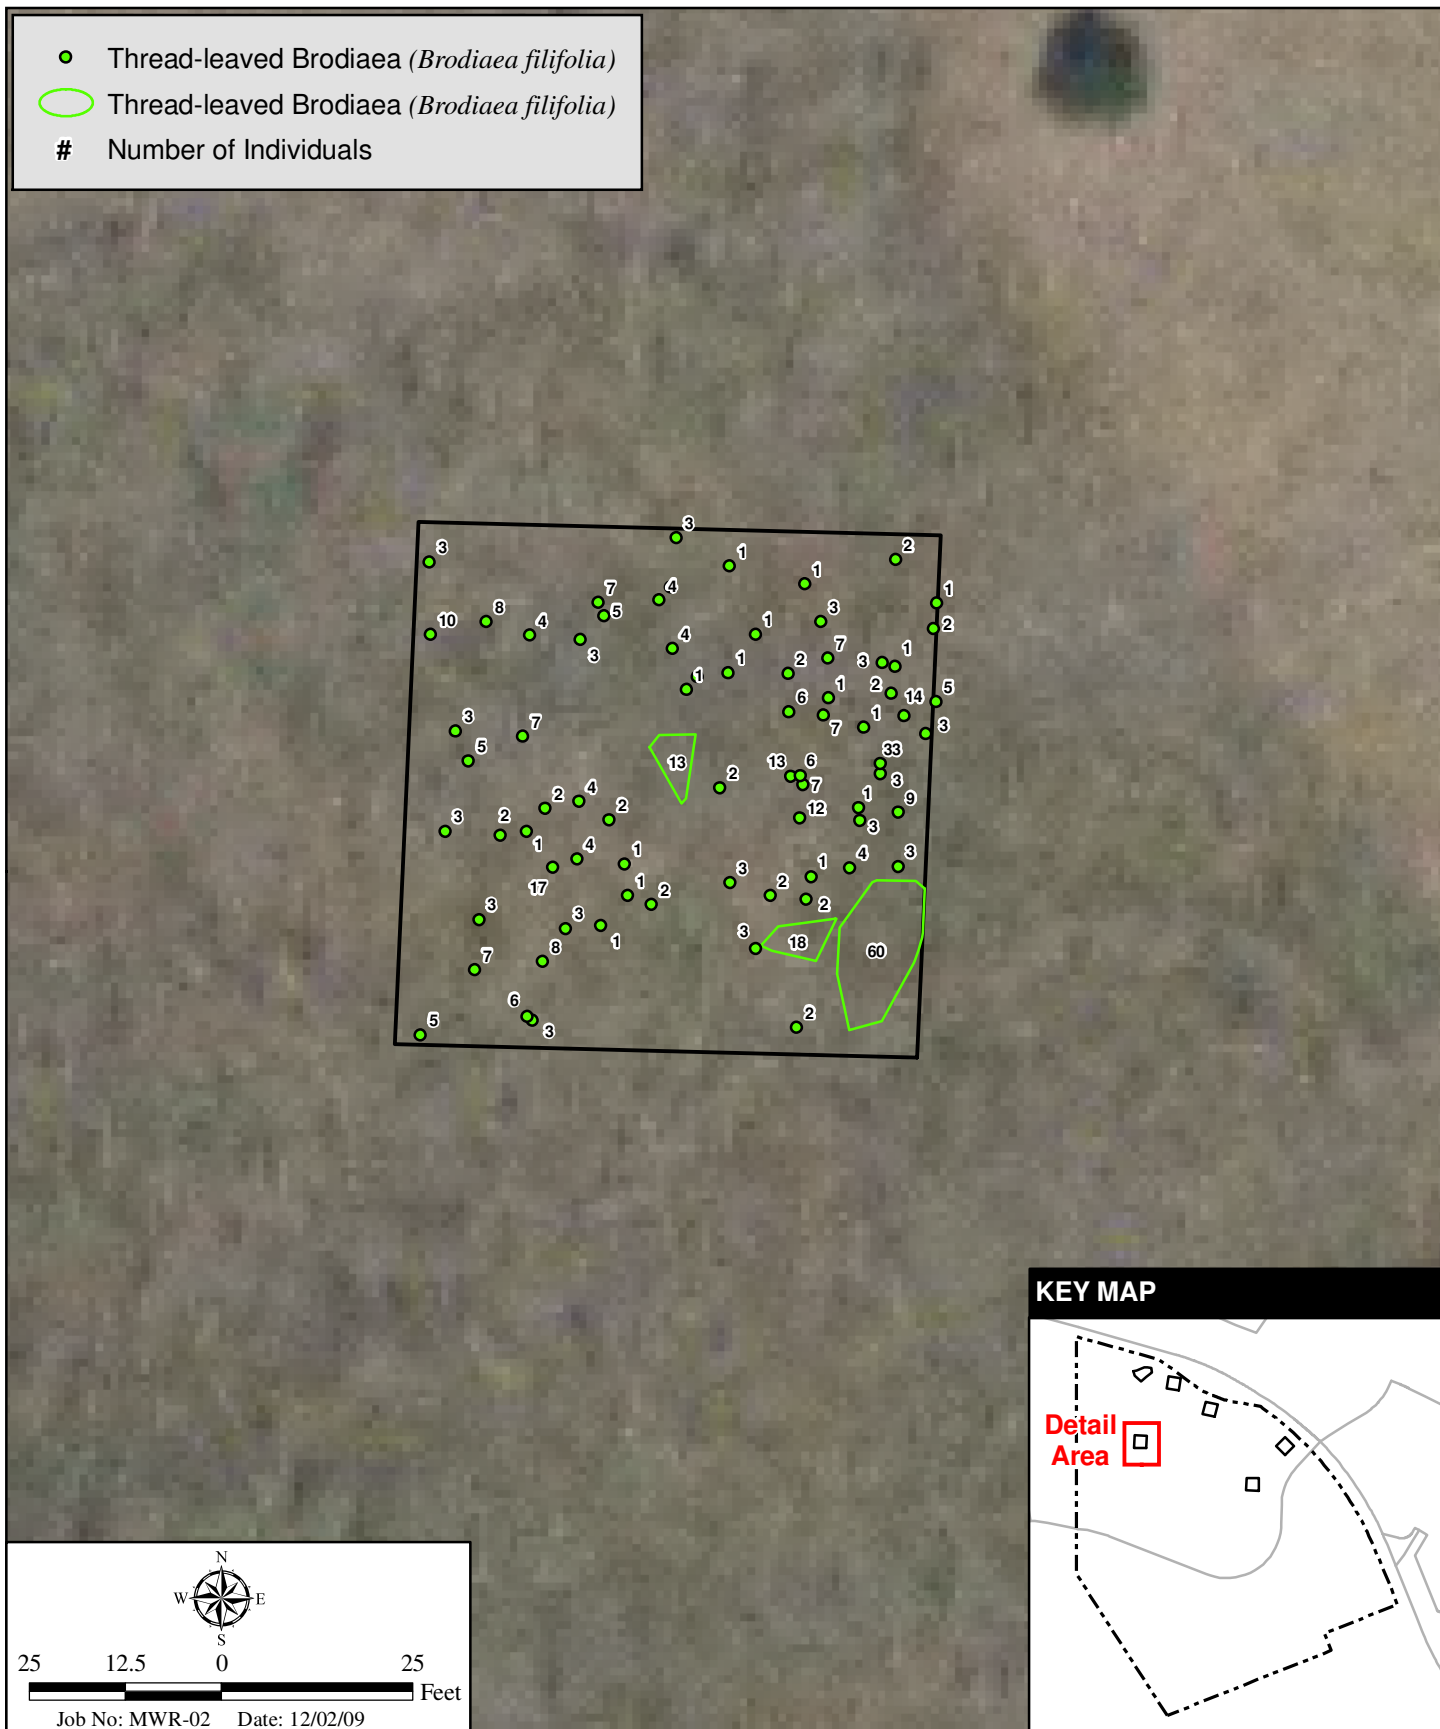
Figure 5f

# Quantity and Distribution of Flowering Thread-leaved Brodiaea (*Brodiaea filifolia*) Individuals - Reference Plot E

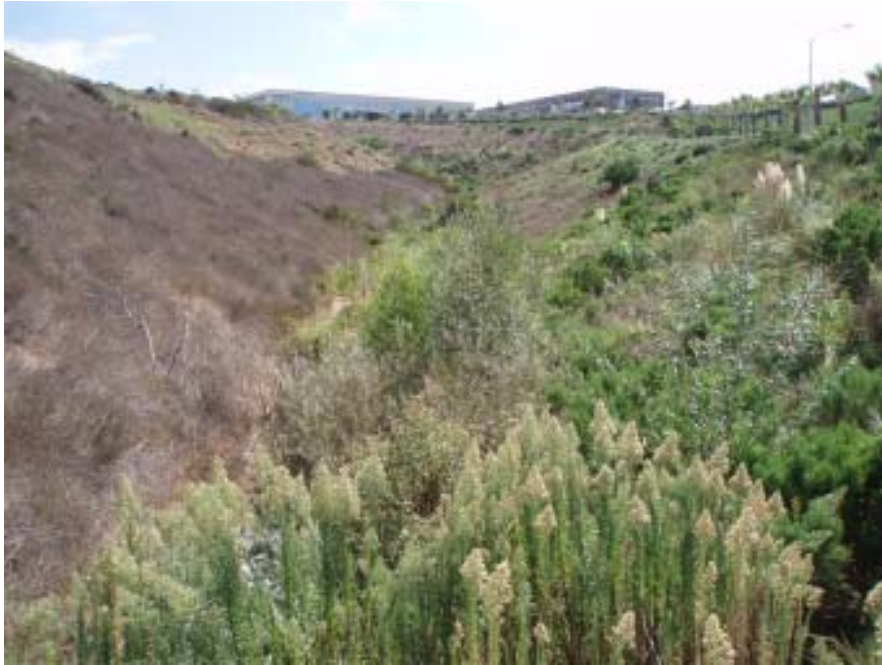
Photo Point 1– southern willow scrub restoration area, looking east.

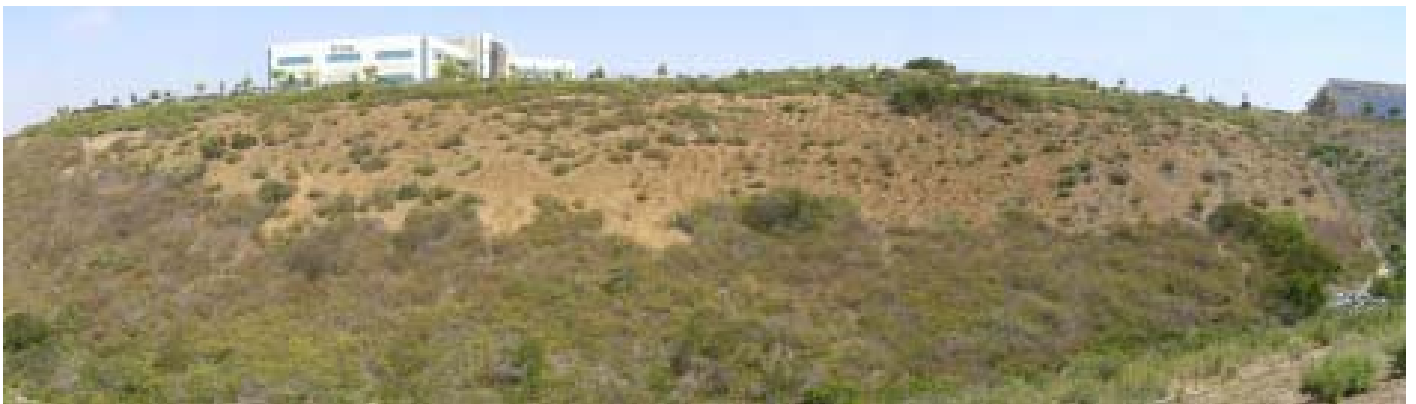
Photo Point 2 – northern Diegan coastal sage scrub restoration slope, looking north/northeast.

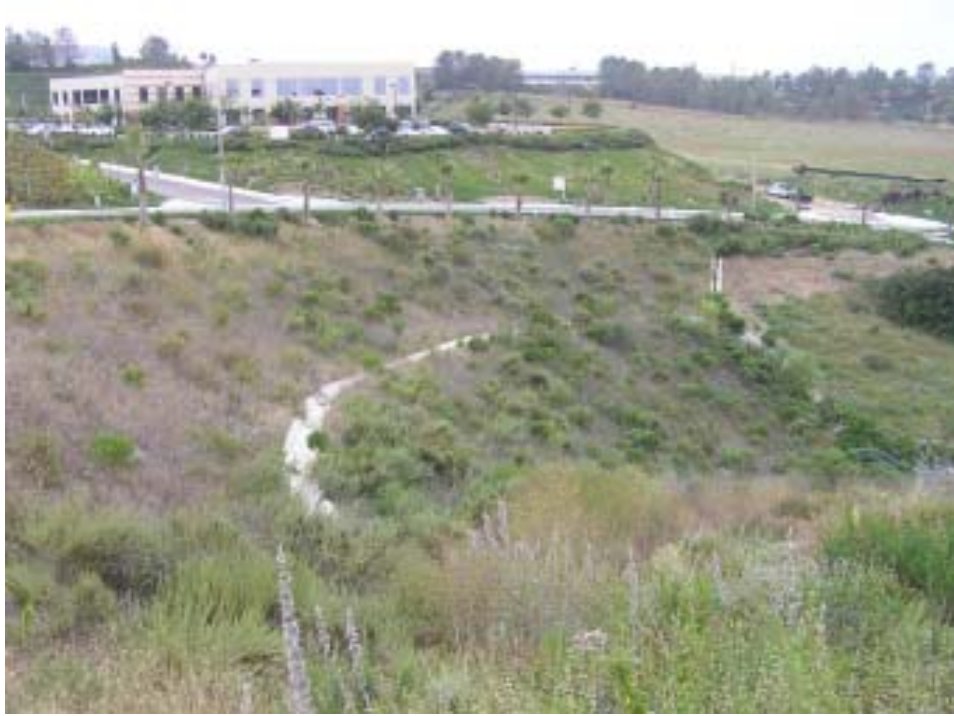
Photo Point 3 – eastern Diegan coastal sage scrub restoration slope, looking south

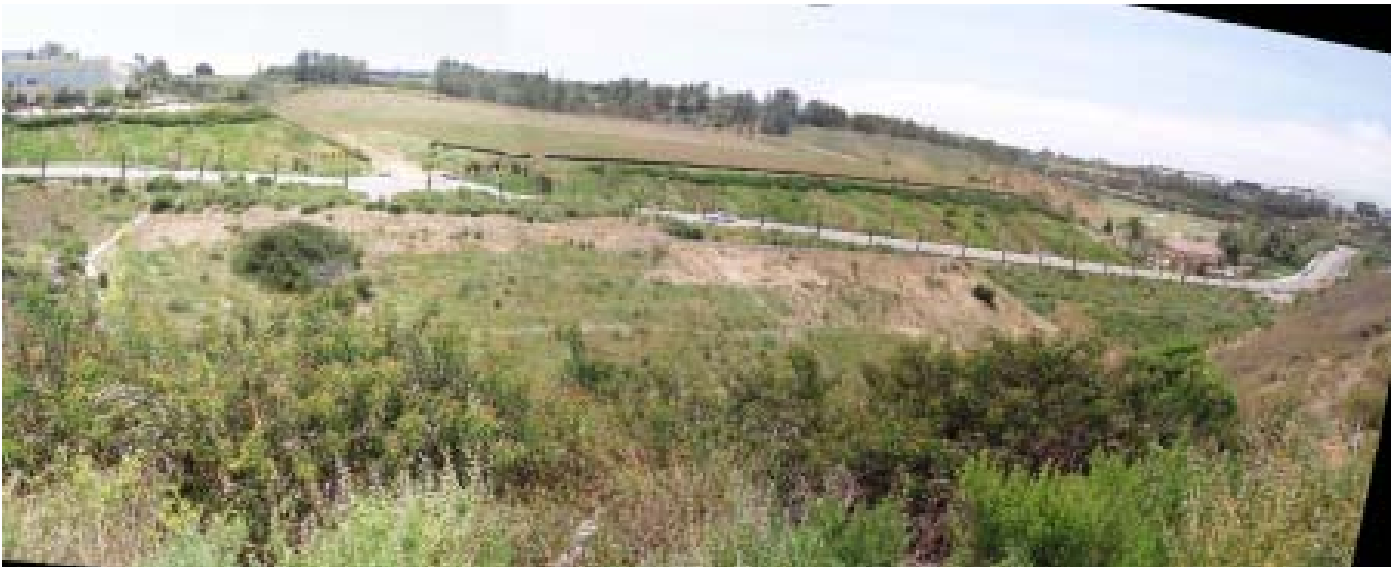
Photo Point 4 – southern Diegan coastal sage scrub restoration slope, looking south

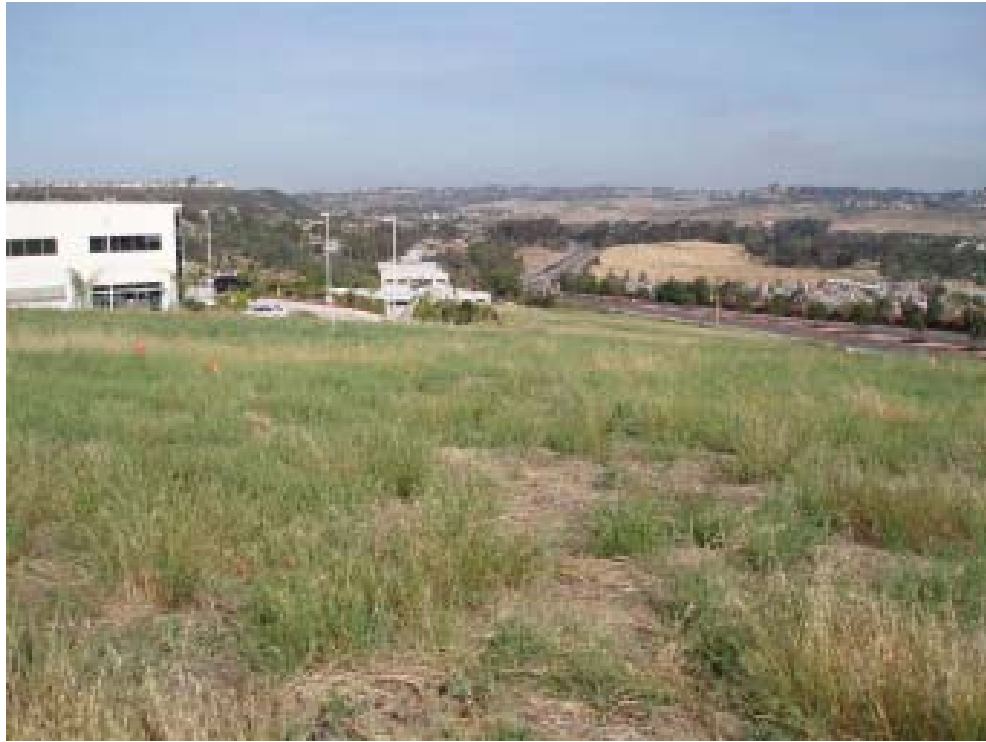
Photo Point 5 - native grassland restoration area, looking northwest

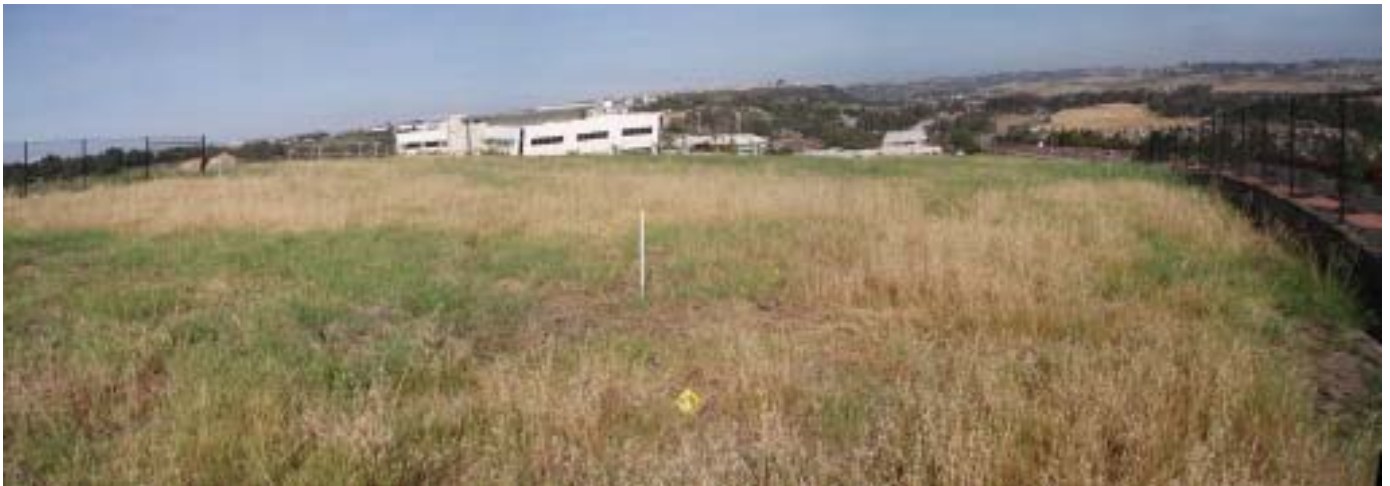
Photo Point 6 - eastern portion of native grassland restoration area, looking northeast to northwest.
